NDI ID PA-00803

# VILLAGE TWO AT NEW HOPE DAM

PHASE I INSPECTION REPORT  
NATIONAL DAM INSPECTION PROGRAM

Name of Dam:	Village Two at New Hope Dam
State Located:	Pennsylvania
County Located:	Bucks County
Stream:	Unnamed tributary of Delaware River
Coordinates:	Latitude N 40° 21.5', Longitude W 74° 57.3'
Date of Inspection:	December 15, 1980

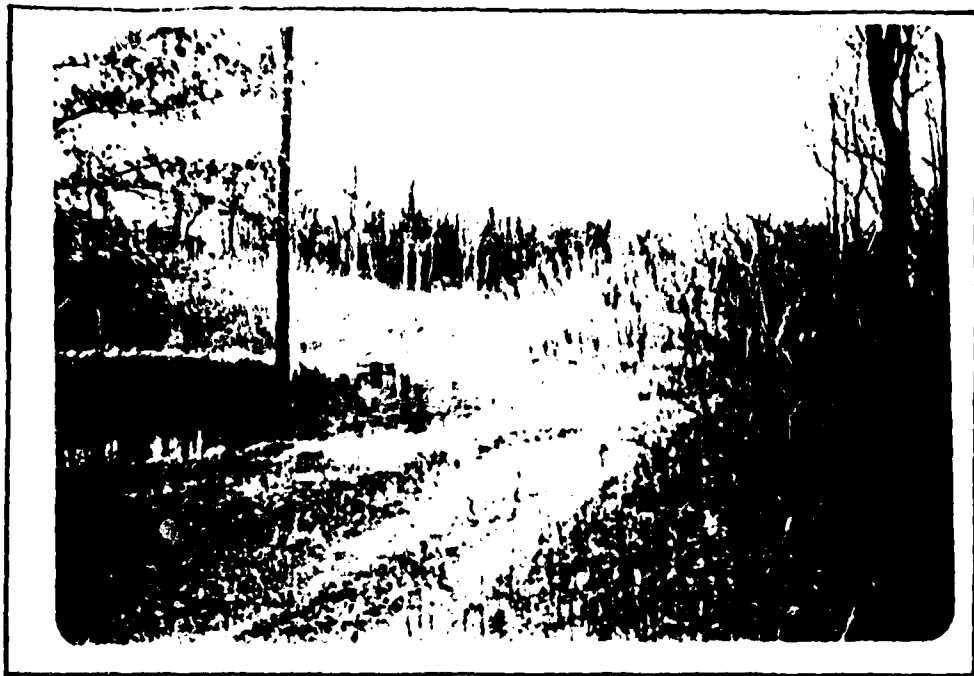
UPSTREAM OVERVIEW FROM THE RIGHT ABUTMENT.

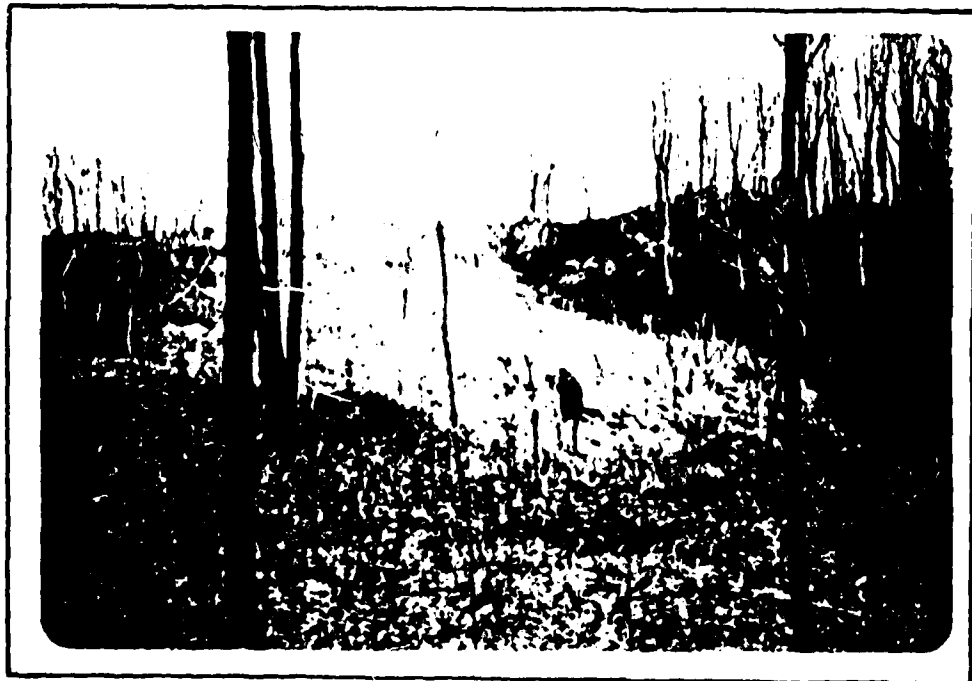
DOWNSTREAM OVERVIEW FROM THE RIGHT ABUTMENT.

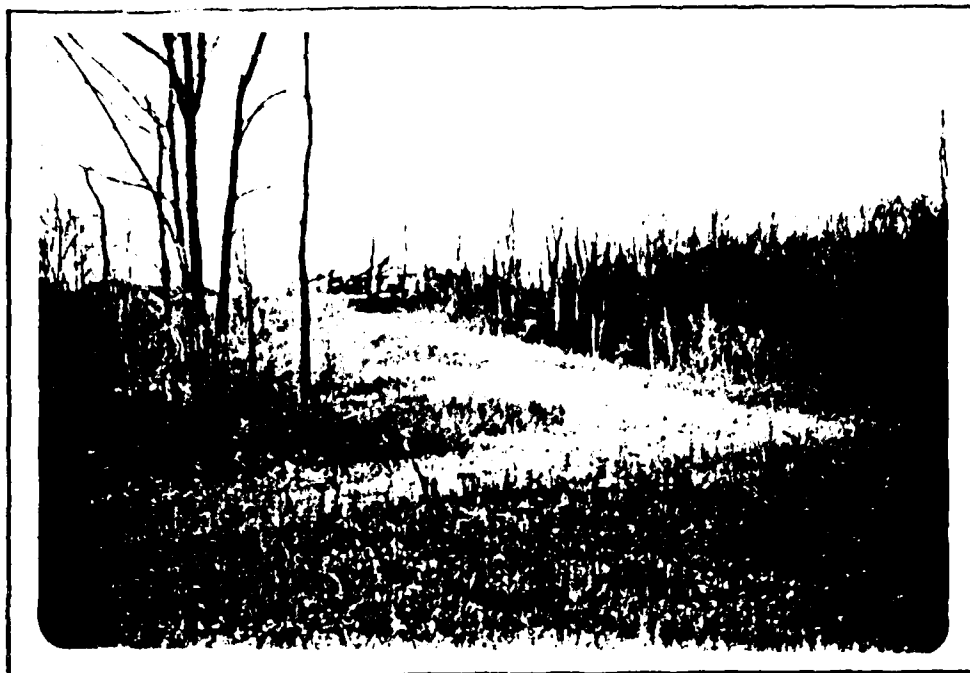
1. VIEW ALONG THE TOP OF THE DAM FROM  
THE RIGHT ABUTMENT. (12/15/80)

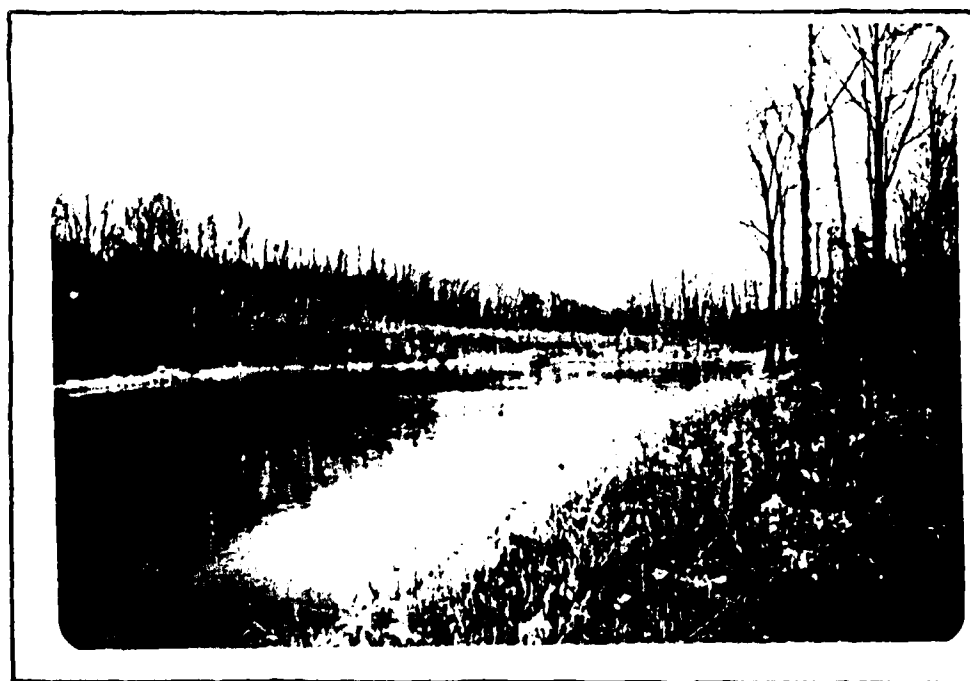
2. IMPOUNDMENT WITH DAM IN THE BACKGROUND  
SHOWING VARIATION IN TOP OF DAM ELEVATION.  
(12/15/80)

1. The right side of the embankment should be built up to the design top of dam Elev. 170 and both the upstream and downstream faces of the embankment

should be constructed as shown on the design drawings. A hydrologic and hydraulic analysis (Appendix D) indicates that by increasing the minimum crest of the dam to Elev. 170.0 the spillway capacity would be increased to approximately 60 percent of the PMF.

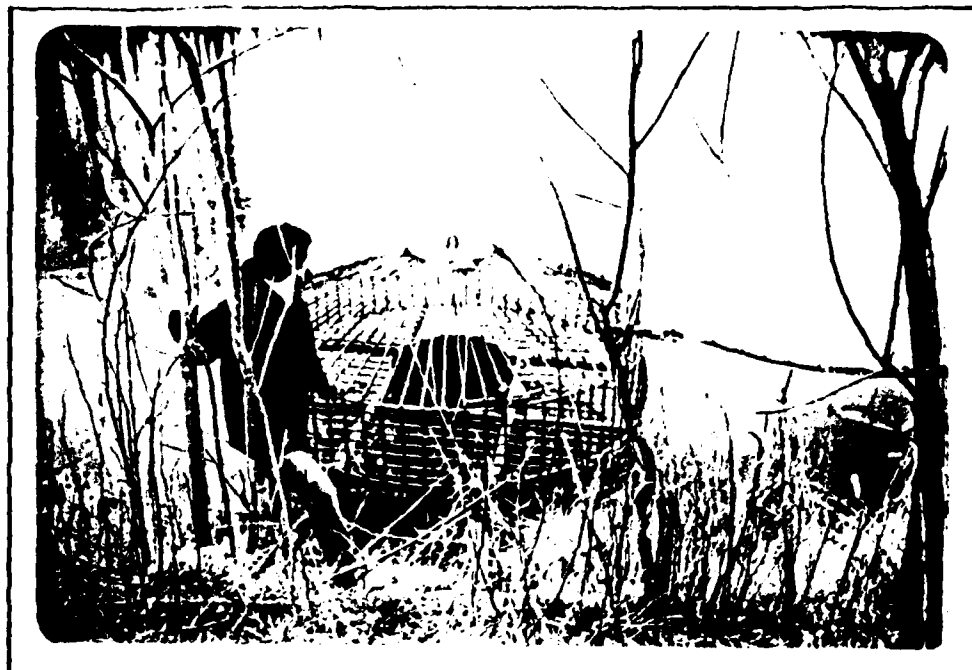
c. Appurtenant Structures. The 36-inch diameter steel riser pipe of the normal overflow spillway appears to be in good condition. Steel rods on the trash rack are too closely spaced, thus discharge would be impeded because of trash build-up. The 8-inch diameter gate valve could not be examined because it is at the base of the 21-foot intake tower. The trash rack must be removed to gain access to the intake riser. No valve stem was observed. The 30-inch diameter steel outlet pipe and the outlet channel appear to be in satisfactory condition.

3. NORMAL OVLRFLOW SPILLWAY ENTRANCE  
WITH STEEL ROD TRASHRACK .(12/15/80)

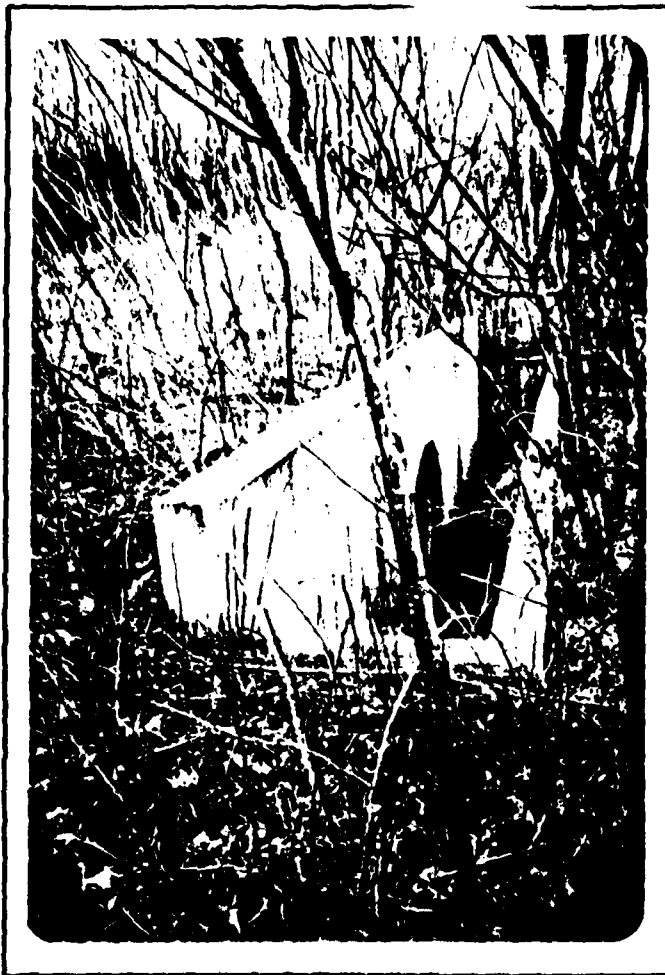
Small trees (up to 4-inch diameter trunks) and brush obstruct flow to the emergency overflow spillway inlet structure. The emergency overflow inlet structure appears to be in good condition except for some honeycombing observed in the concrete. Gaps were left around the perimeter of the 48-inch diameter reinforced concrete outlet pipe where it joins the downstream wall of the inlet structure (see Appendix C, Photographs No. 6). The invert of the four foot outlet pipe is about 26 feet above the valley floor where it outlets on the right abutment downstream within a few feet of the downstream face of the dam. Discharge from the emergency overflow spillway outlet pipe would tend to erode the downstream

5. ENTRANCE TO EMERGENCY  
OVERFLOW SPILLWAY.  
(12/15/80)

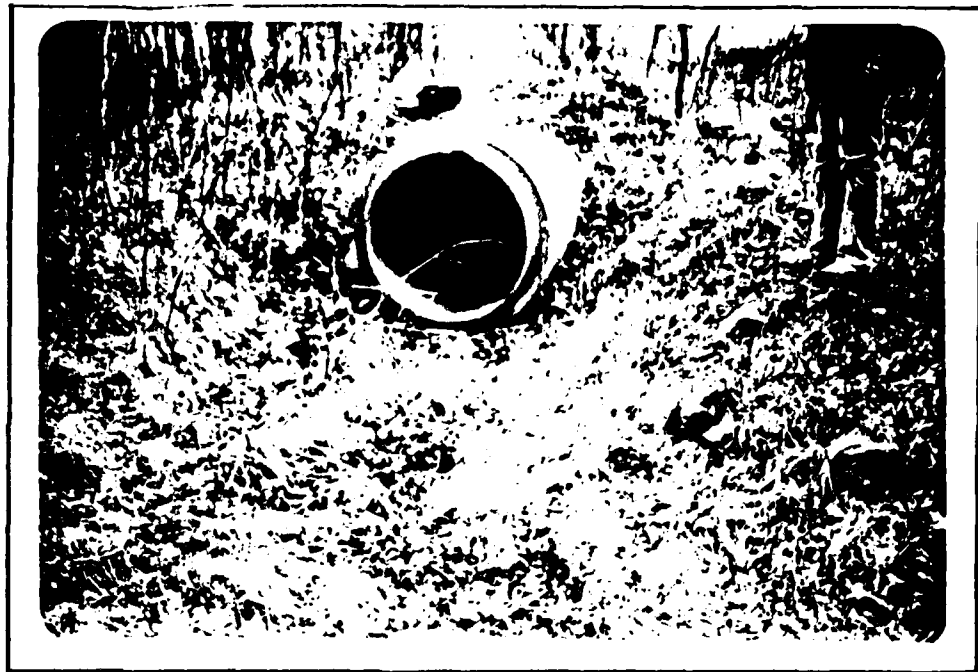
The invert of the outlet of the emergency overflow spillway four foot diameter outlet pipe is located about 26 feet above the outlet channel near the downstream face of the dam. Discharge from the outlet pipe would flow over the unprotected embankment. The fitting of this pipe into the emergency overflow spillway inlet structure's downstream wall is in poor condition.

7. OUTLET OF 48-INCH DIAMETER EMERGENCY SPILL-  
WAY PIPE .(12/15/80)

4. Provisions should be made to insure that discharge from the 48-inch diameter emergency overflow spillway outlet pipe will not damage the downstream embankment. Repairs should be made to the connection of this pipe into the downstream wall of the emergency overflow spillway inlet structure.

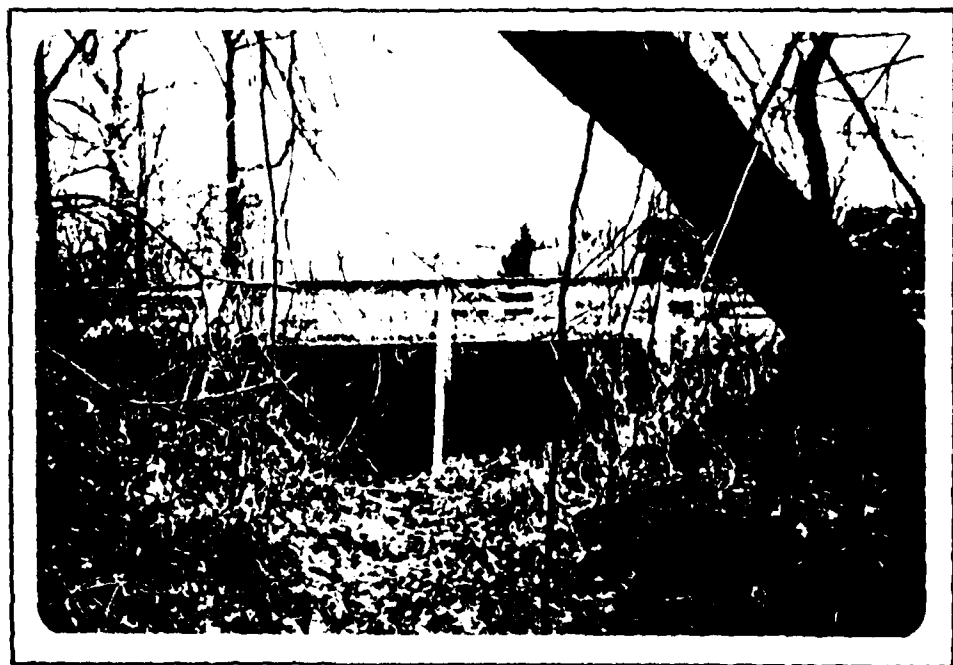
10. BRIDGE OVER CHANNEL ABOUT 1,100 FEET DOWN-STREAM OF THE DAM. (12/15/80)
